SECTION 3 Existing Conditions/Code Review

SECTION 3.1 Existing Conditions Summary

Graham Meus Architects in conjunction with DMC Engineering and GZA Geo Environmental have compiled a Unifomat report outlining the existing conditions of 29 Church Street. The following pages summarize the complete report found in Section 3.3.

Hudson Senior Center
Feasibility Study February 2007

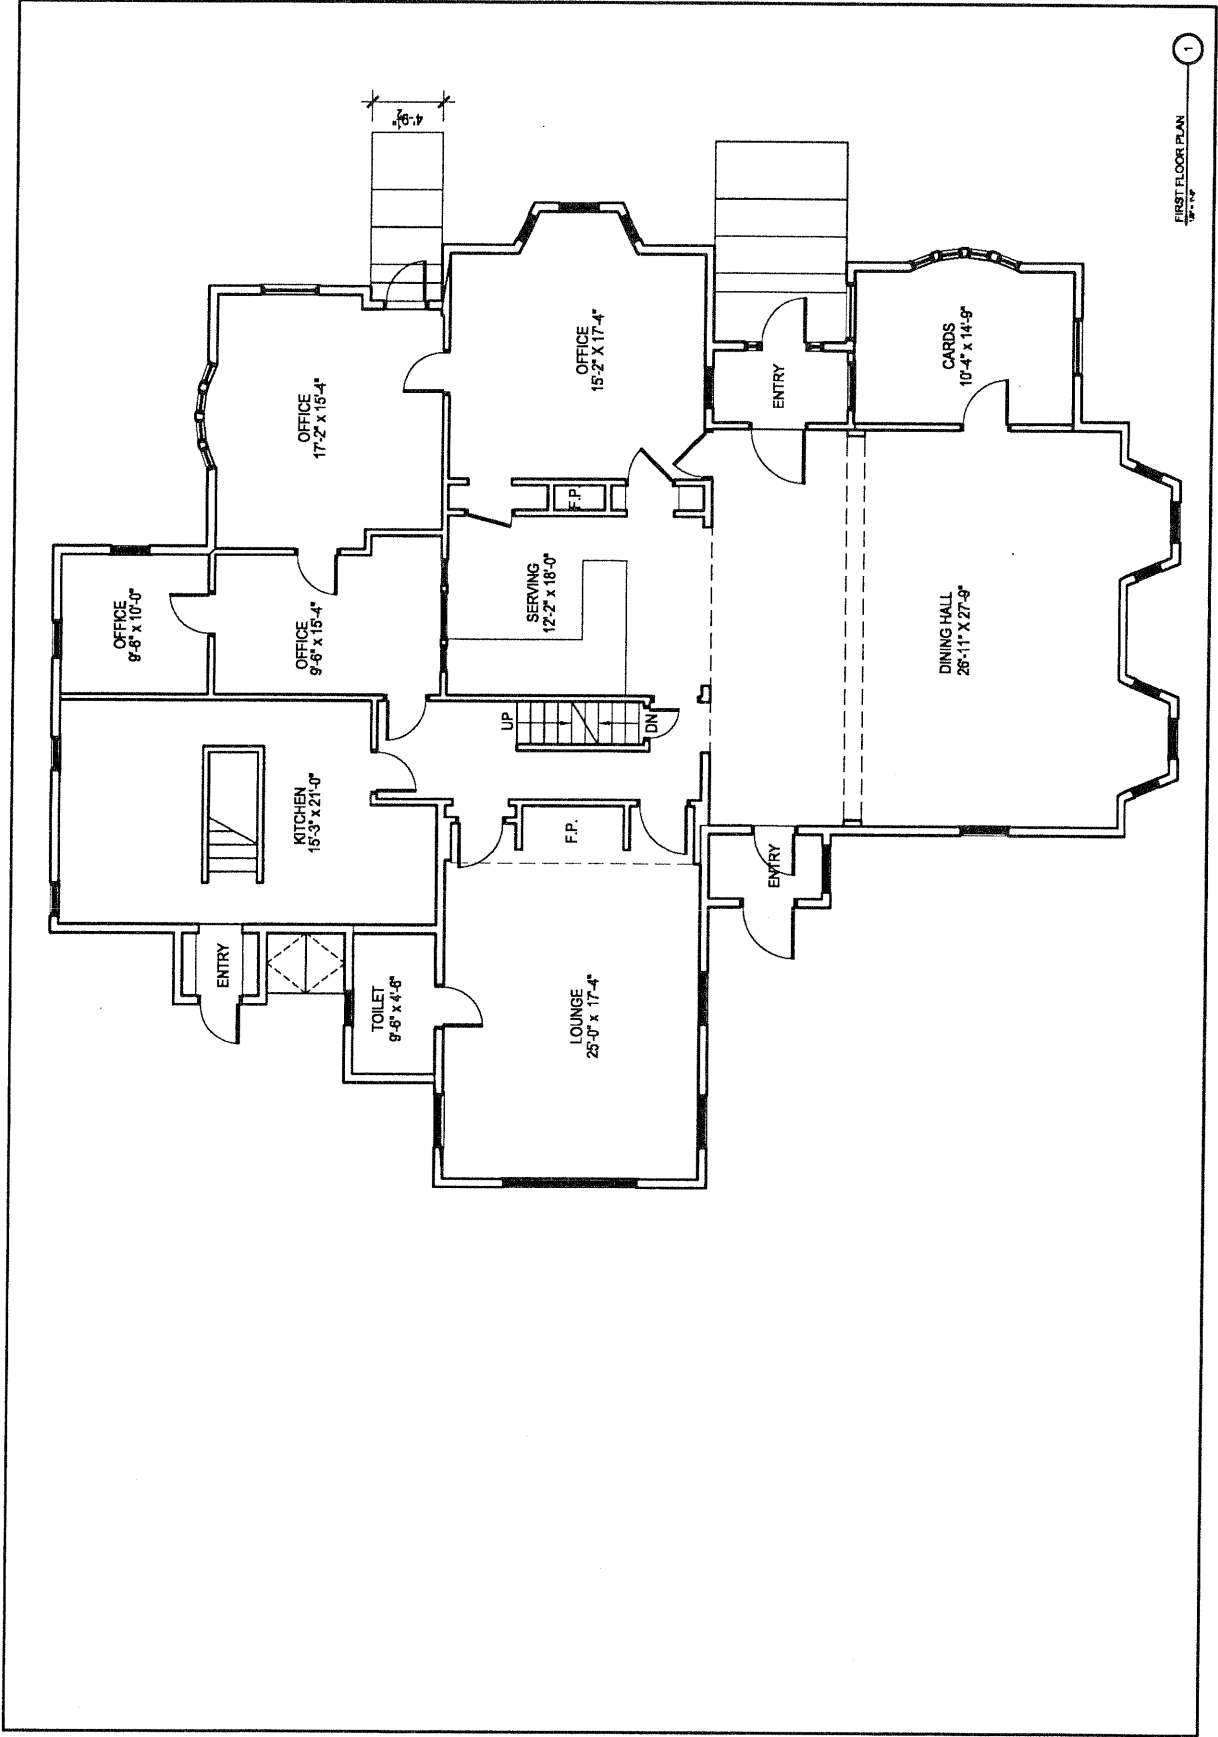
A1.0

The second plan, A1.0, contains the existing conditions of the first floor. The rear of the building (the addition) contains mostly offices. The kitchen is believed to be part of the original house, however is located in the rear of the main floor. Adjacent is the Library, which the seniors also use as a multi-media room with a TV. The only toilet room on this floor is located in the Library. There are two main entrances both leading to an open area, which the seniors use as a multi-purpose room.

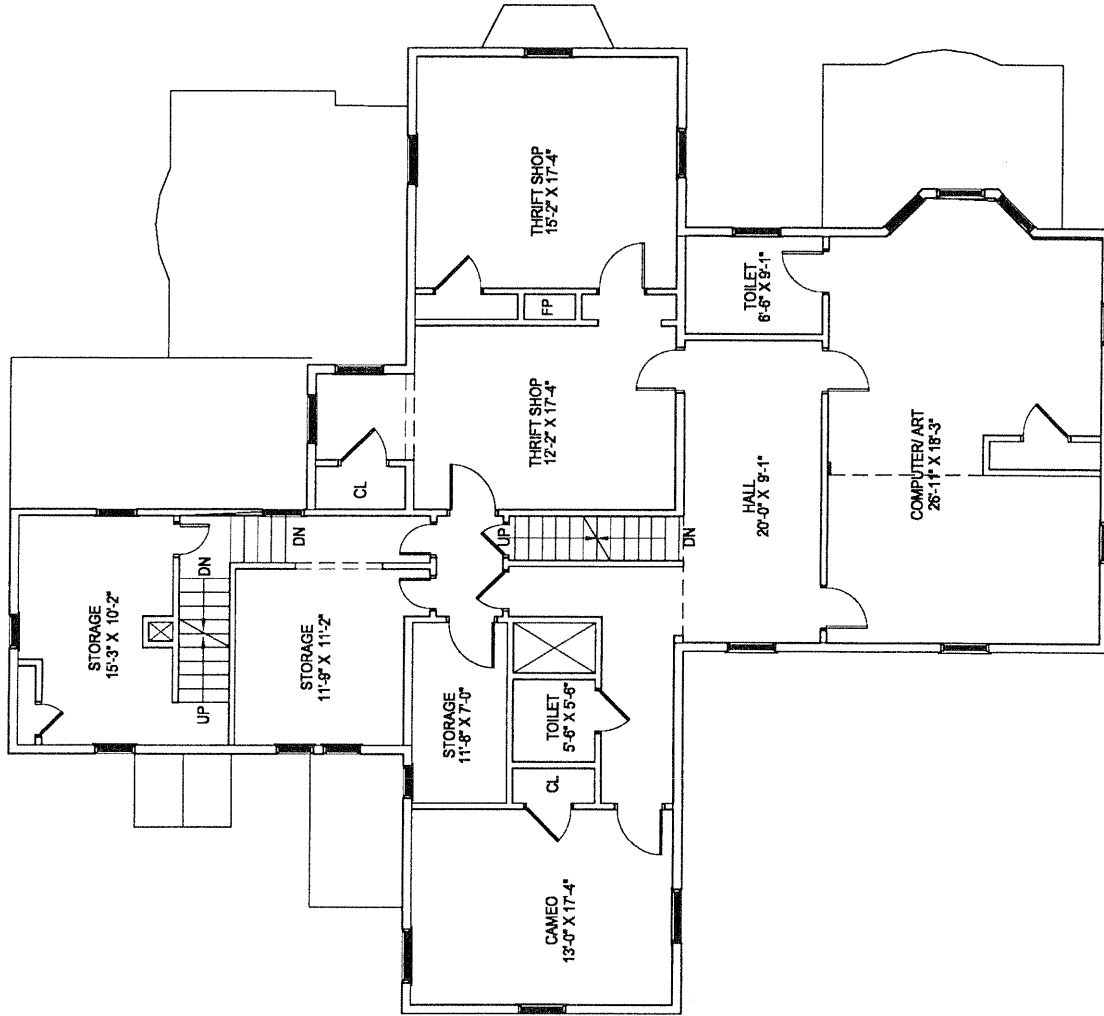
A1.9

The third plan, A1.2, contains the existing conditions of the second floor. This floor is used mainly for classrooms, the thrift shop and storage. There are two toilet rooms on this floor, one in the corridor at the top of the stairs and another off the computer/ art room. The main stair that leads to this floor does not comply with current building code requirements.

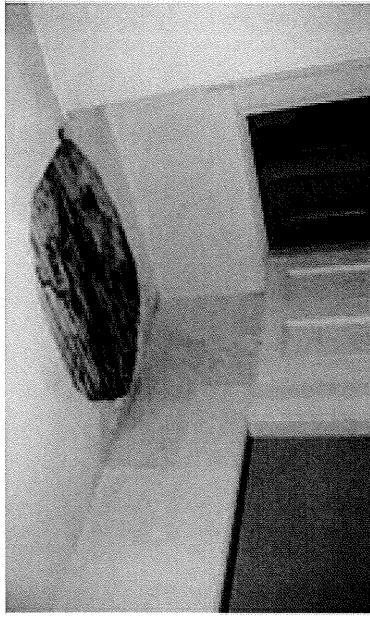
Second Floor- Ceiling Damage
